<i>Seabed Sampling and Baited Camera Operations</i>	
Vessel	R/V Ocean Veritas
Summary Report Number	13
Operating equipment	MAXI Corer (8 core unit)
Date	13 October 2010
Completed casts (12 hr)	05
Report compiled by	Emily Gould

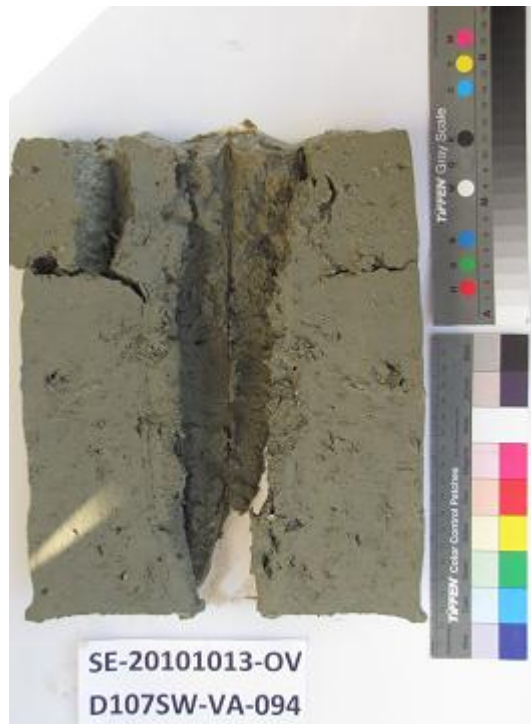
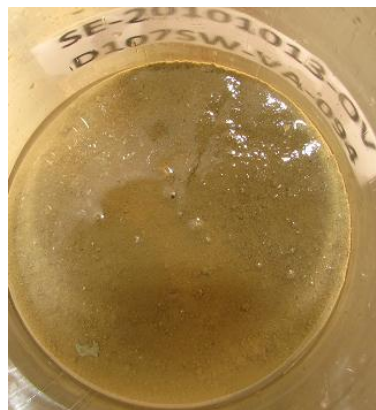
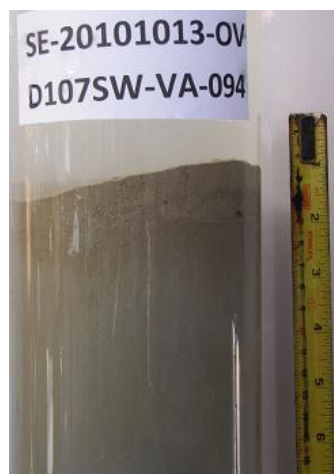
## Station D107SW

Recovery: 24 cm

Visible contamination: None

Olfactible contamination: None

Recovery: 36 cm

Description: Olive, very soft, homogenous sandy silt, becoming soft.

Biota: Polychaetes.

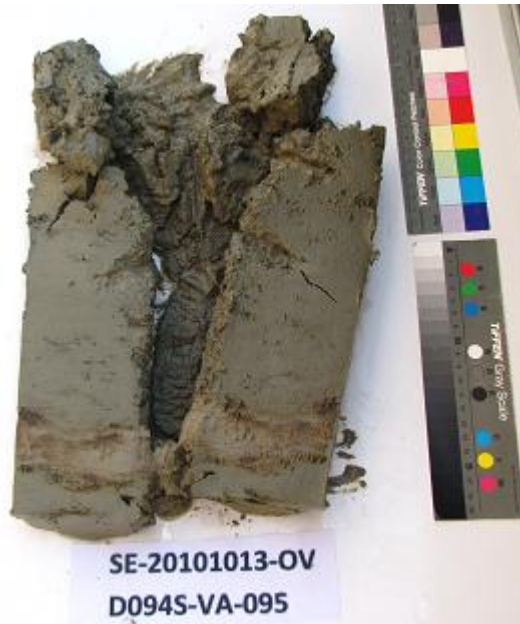
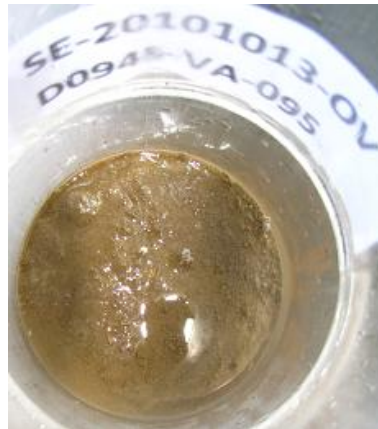
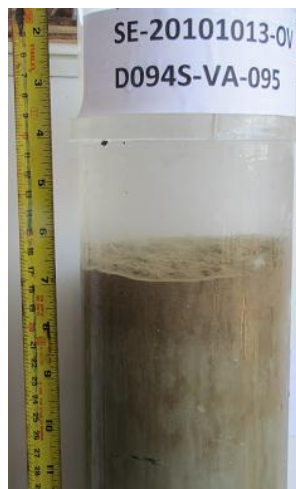
## Station D094S

Recovery: 22 cm

Visible contamination: None

Olfactible contamination: None

Recovery: 38 cm

Description: Olive grey, very soft, homogenous sandy silt, becoming soft.

Biota: None.

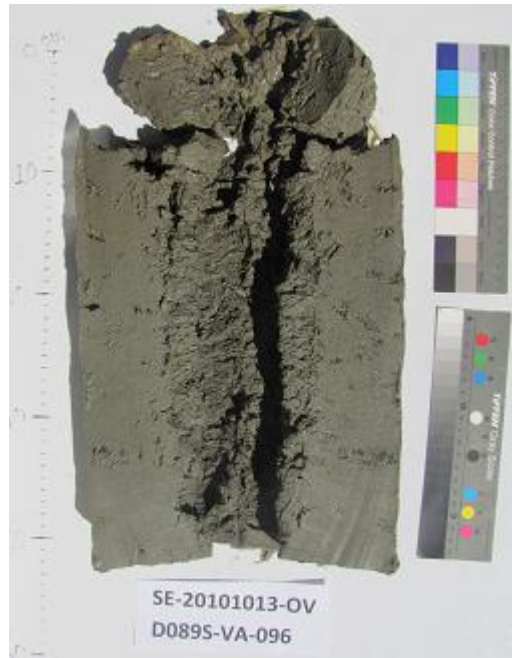
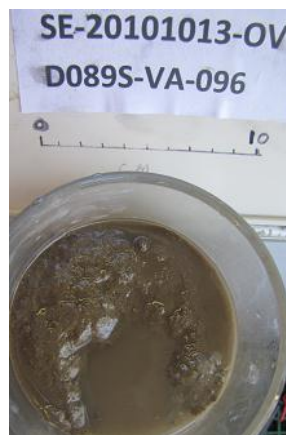
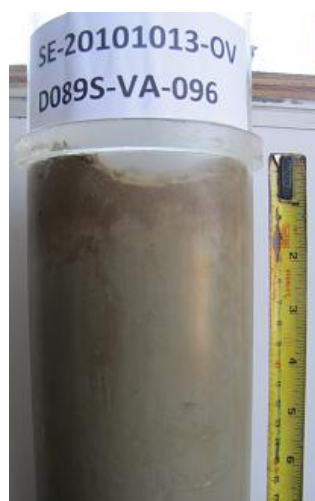
## Station D089S

Recovery: 16 cm

Visible contamination: None

Olfactible contamination: None

Recovery: 44 cm

Description: Olive grey, very soft, homogenous silty clay.

Biota: Amphipod.

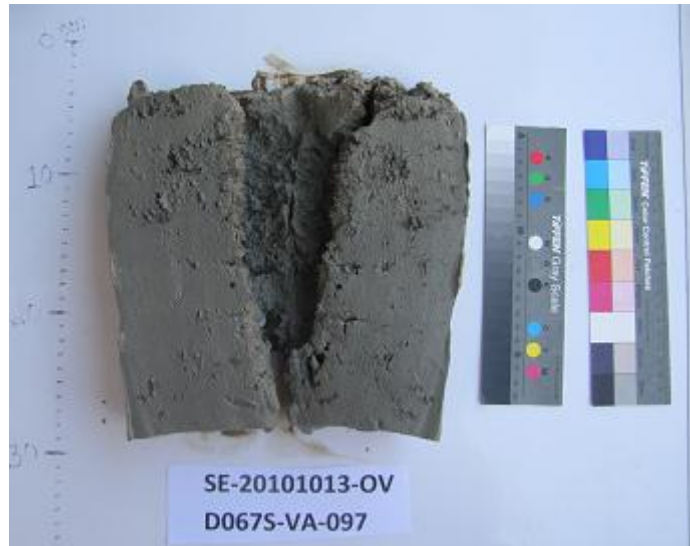
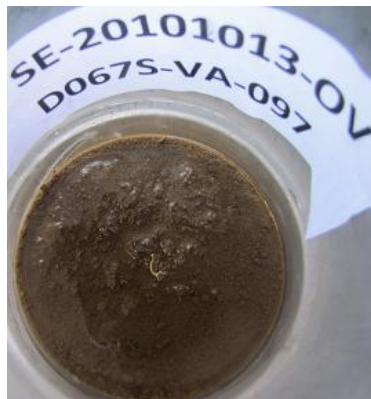
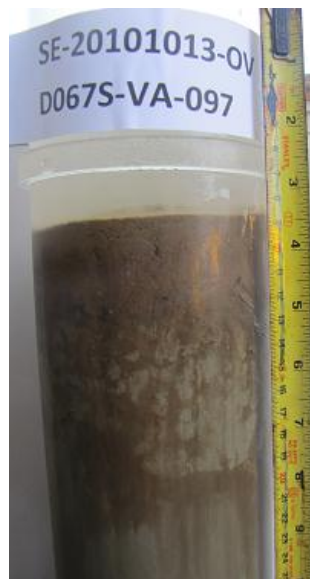
## Station D067S

Recovery: 17 cm

Visible contamination: None

Olfactible contamination: None

Recovery: 43 cm

Description: Olive grey, very soft, homogenous silty clay.

Biota: None.

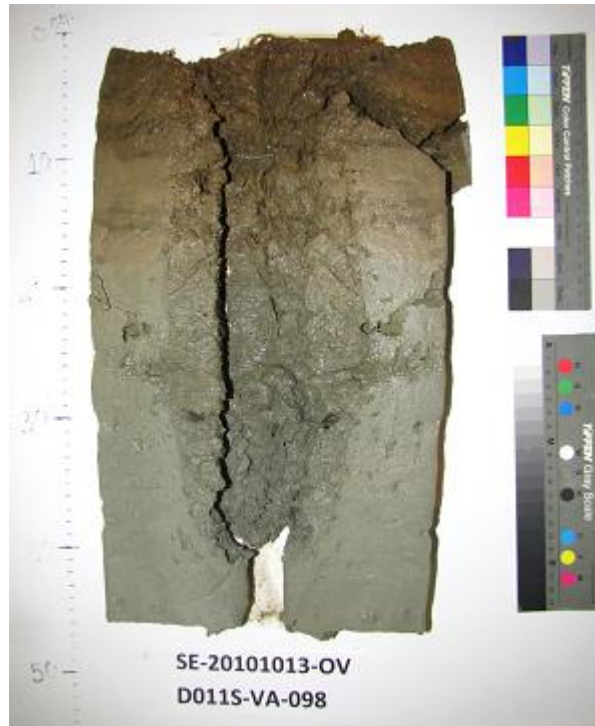
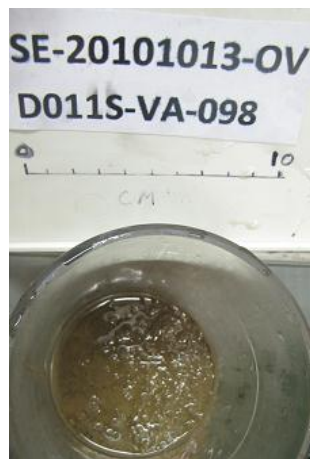
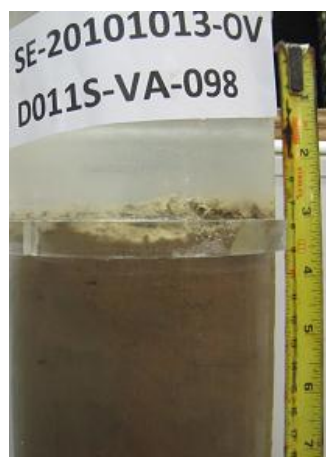
## Station D011S

Cores recovered: 5 of 8

Recovery: 14 cm

Visible contamination: None

Olfactible contamination: None

Recovery: 46 cm

Description: Top 10cm olive, fluidized sediment, becoming light olive grey, soft, homogenous silty clay.

Biota: None.
